# RF50-FR

Rear Fixed 50mm Fire Rated Rainscreen System

### **CLASSIFICATION REPORT EUI-20-000374- Revision 1**

## **FIRE PERFORMANCE CLASSIFICATION IN ACCORDANCE WITH BR 135 (3<sup>rd</sup> edition): 2013, as tested according to BS 8414-2:2020.**

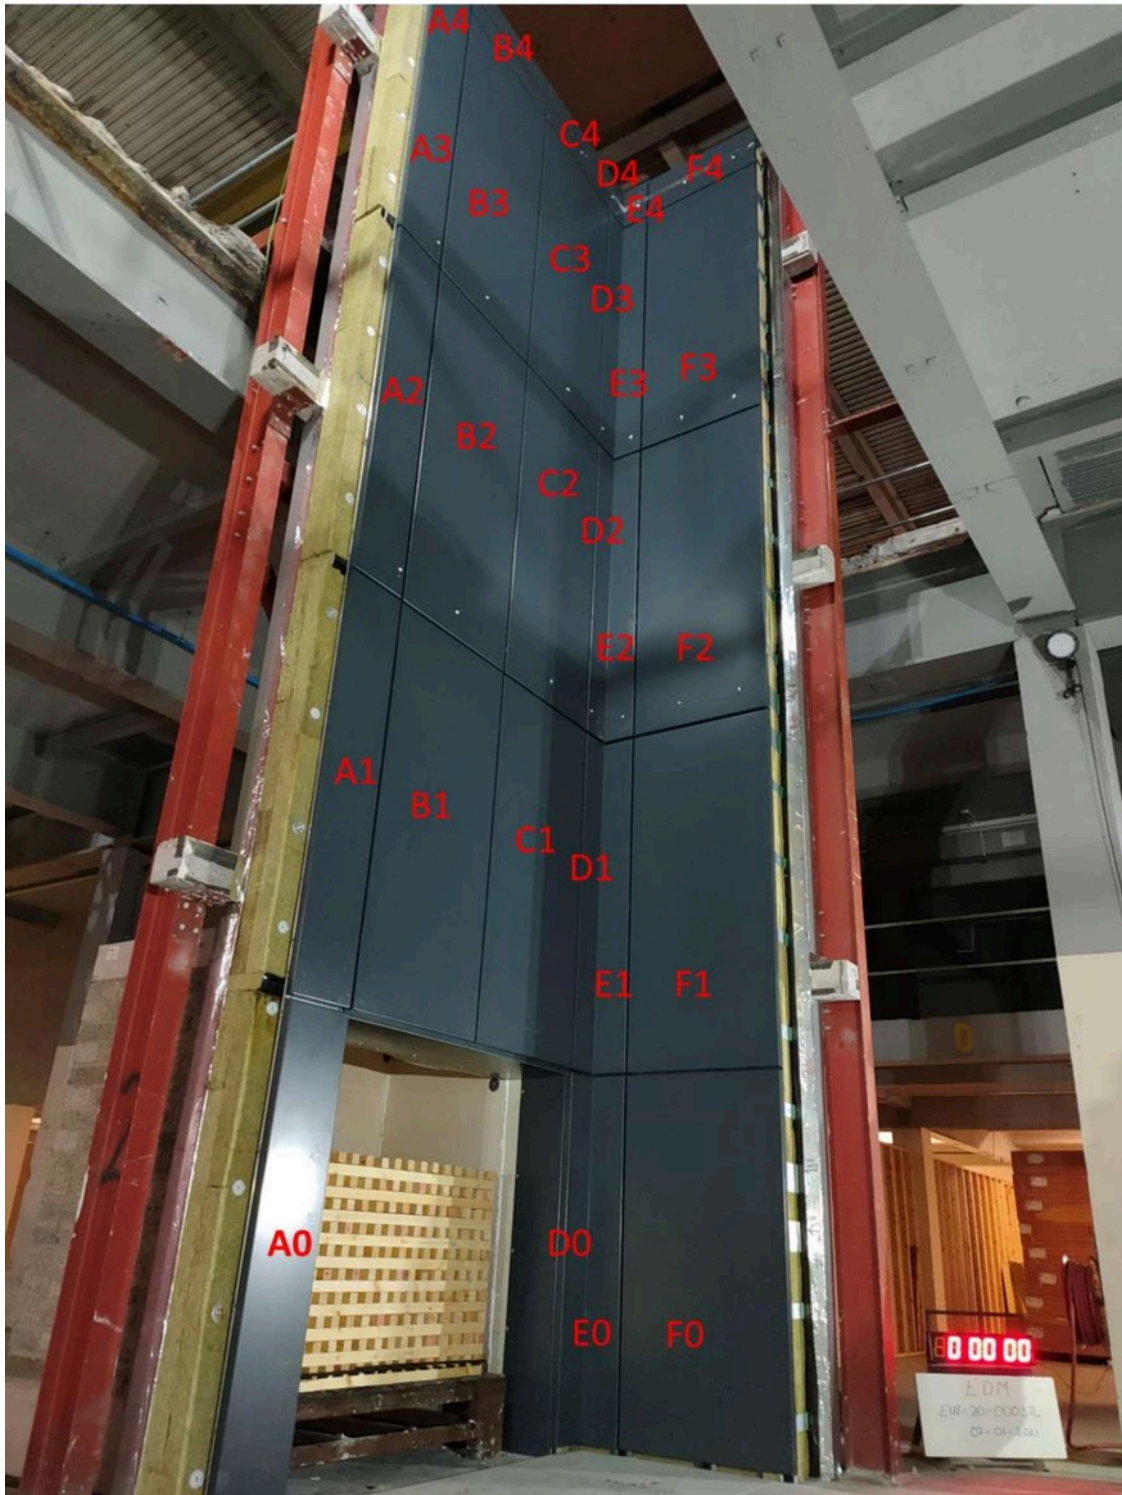
Figure 27. Panel numbering added by the testing laboratory.

Panels A0, A1, A2, A3, A4, B3, B4, C3, C4, D0, D1, D2, D3, D4, E0, E1, E2, E3, E4, F0, F1, F2, F3 and F4 remain intact and in-place after testing.

Panels B1 and C1 melted and collapse by about 60% on the left-hand and right-hand side, respectively. Panels B2, C2 melted and collapse by about 5% on the bottom middle corner.

Panels A0, A1, D0, D1, E0, E1: Some discolorations/delamination were noticed on the side exposed to the opening of the combustion chamber.

Panels F0 and F1: These 2 panels show some minor deformations. Also, discoloration and delamination were noticed on the panels, approximately 30% of the panels.

Panels B1 and C1: Melted by about 60% on the left-hand and right-hand side, respectively. The rest was deformed and discoloured/delaminated.

Panels B2, C2: Most of the panels remain in place after testing. Approximately 5% of the panels melted on the bottom middle corner. 50% of the panels were discoloured and out of this 50%, 20% was delaminated. This panels also show some deformation.

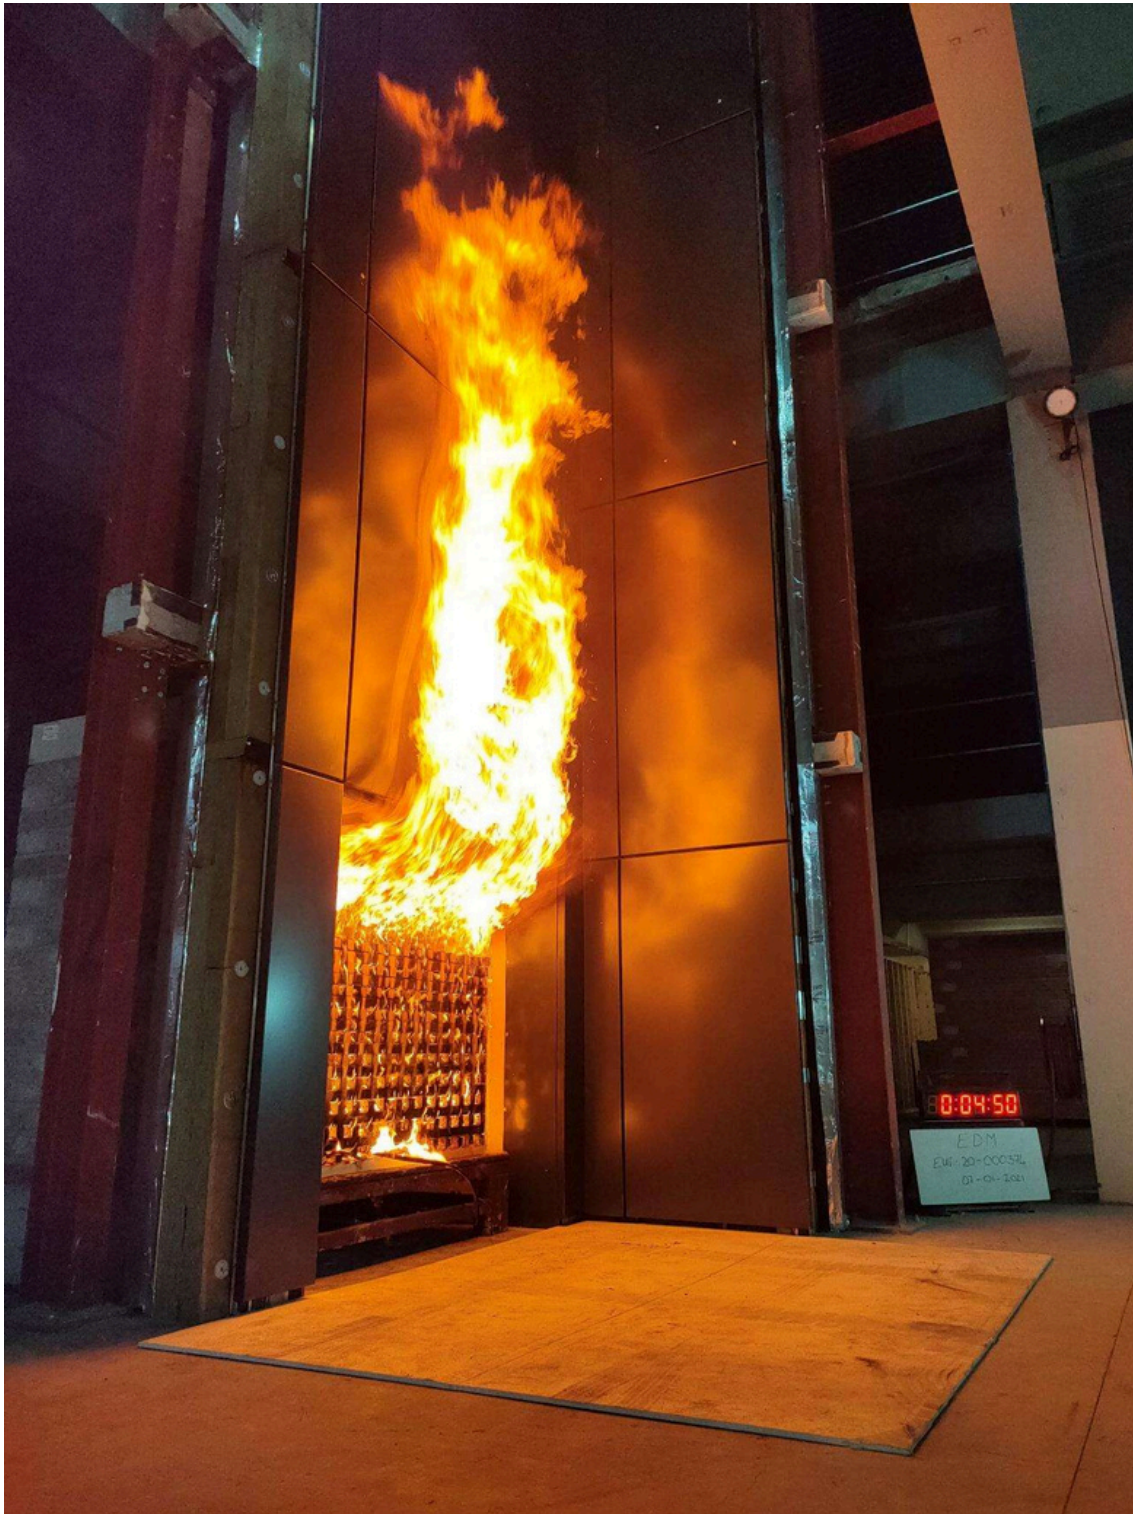
The system collapse started at 4 min 20 s after ignition

The combustion chamber panels fall after 04 min 36s after ignition.

Figure 28. Cladding system during the fire test (4 min 50 sec after ignition of the crib).

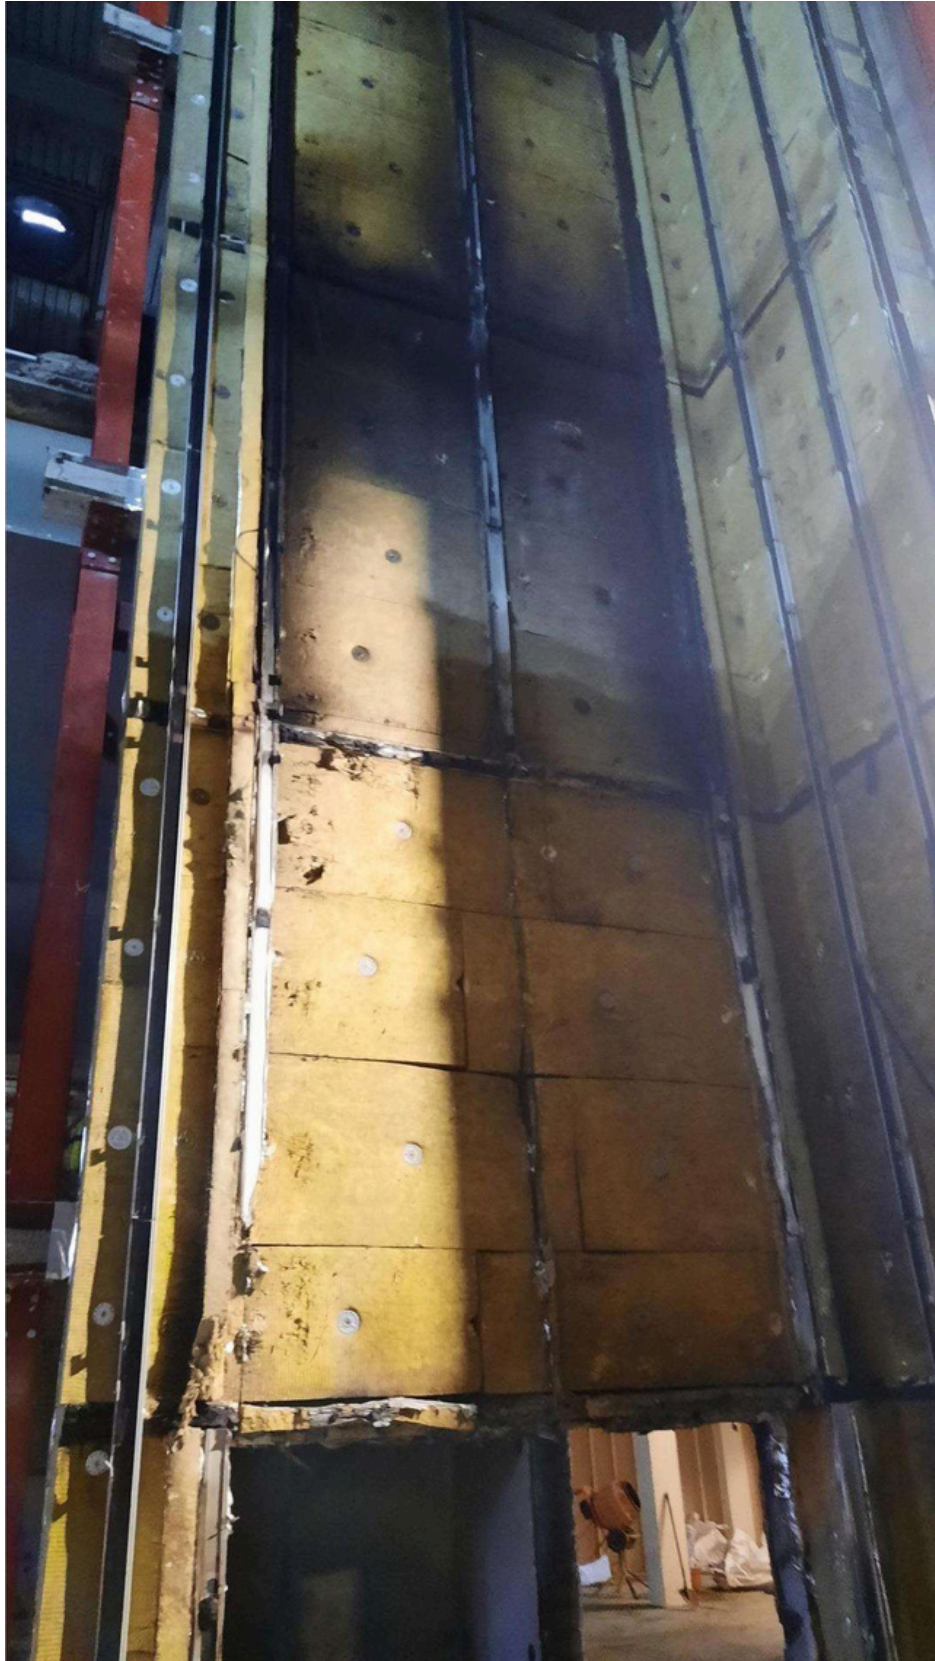
The vertical barriers located on either side of the opening were in-place after testing having suffered some discolouration starting at approx. 1500 mm to the 2<sup>nd</sup> horizontal cavity barrier. Some smoke staining was noticed on the full length of the vertical cavity barriers.

All Rockwool Rainscreen Duo Slab (ROCKWOOL) remained intact and in-place after testing, with heat damage and discolouration visible on the main face of the specimen.

On the main face, above the opening and up to about 4 377.5 mm (up to the 2<sup>nd</sup> cavity barrier) white discolouration covering about 3.8 m<sup>2</sup> surface area between the 2 vertical cavity barriers. On the same area, some of the insulation slabs were of rough texture with visible signs of damage. Above the 2<sup>nd</sup> cavity barrier and up to the 3<sup>rd</sup> one, insulation slab suffered some white discoloration, approximately 2 m<sup>2</sup> and some black stain discoloration, approximately 2 m<sup>2</sup>. Finally, from the 3<sup>rd</sup> cavity barrier to the top of the specimen, insulation slabs suffered black discolouration covering about 1.6 m<sup>2</sup>. Above that the insulation remains intact.

The slabs closest to the side edges, outside the vertical barriers had no discolouration observed.

Figure 32. Damage investigation – Insulation and fire cavity barrier after the test.
